Re: International Harvester Site, Chicago, Illinois TDD #5-8704-07

TAT-05-G2-00394

SITE ASSESSMENT

INTERNATIONAL HARVESTER CHICAGO, ILLINOIS

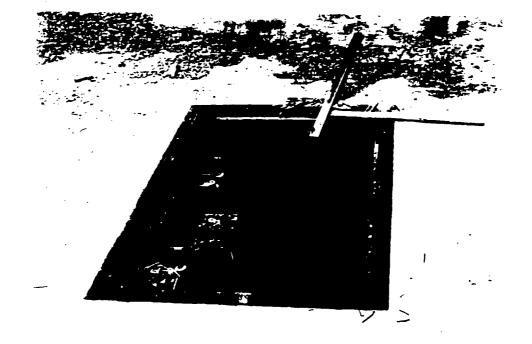
Underground tanks were not evident, although an extensive storm sewer system existed. Some of the chambers were greater than 20 feet deep and contained varying amounts of water. The drains appeared to be clogged, as most of the entrances to the system lacked manhole covers and debris was observed in the chambers.

Open sewer chamber (?), partially water-filled.

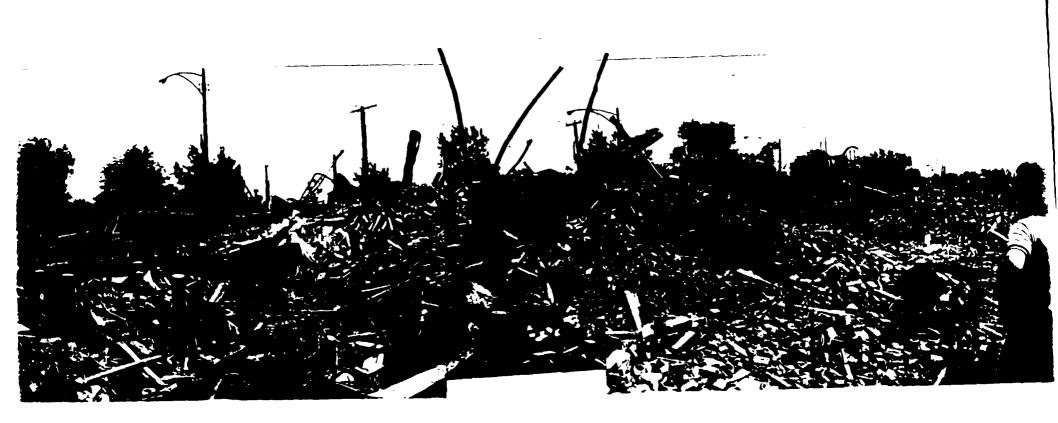
Debris pile exhibiting heterogeneous nature of piles,

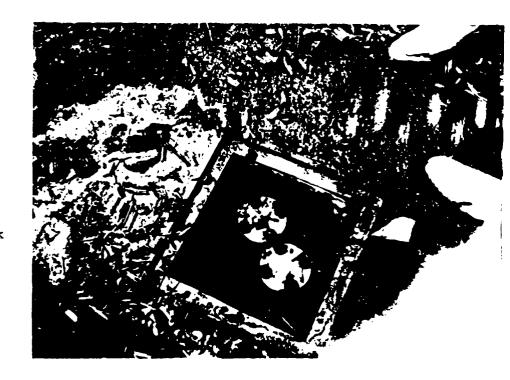
Pipes which possibly lead to underground tanks

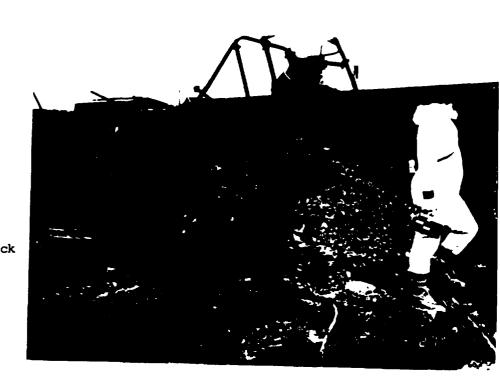
Remains of electrical substation
